Intel[®] Pentium[®] 4 Processor Specification Update

Release Date: January 2002

Order Number: 249199-017

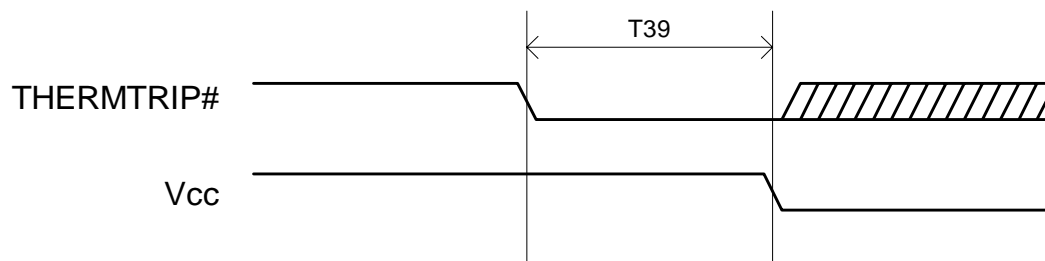
The following figure will be added as Figure (new). THERMTRIP# Power Down Sequence

Assertion of THERMTRIP# (Thermal Trip) indicates the processor junction temperature has reached a level beyond which permanent silicon damage may occur. Measurement of the temperature is accomplished through an internal thermal sensor which is configured to trip at approximately 135°C. Upon assertion of THERMTRIP#, the processor will shut off its internal clocks (thus halting program execution) in an attempt to reduce the processor junction temperature. To protect the processor, its core voltage (V_{CC}) must be removed following the assertion of THERMTRIP#. See Figure (new) and Table 13 for the appropriate power down sequence and timing requirements. Once activated, THERMTRIP# remains latched until RESET# is asserted. While the assertion of the RESET# signal will de-assert THERMTRIP# , if the processor's junction temperature remains at or above the trip level, THERMTRIP# will again be asserted after RESET# is de-asserted.

<u>T# Parameter</u>	<u>Min</u>	<u>Max</u>	<u>Unit</u>	<u>Figure</u>	<u>Notes</u>
T39: THERMTRIP# to removal of power	N/A	500	ms	(new)

$T39 < 0.5$ seconds

Note: THERMTRIP# is undefined when RESET# is active
